Manhole Inspection Summary

Manhole # S15G__020MH

Location Address: **2571 FAYETTA-FAIRMONT**

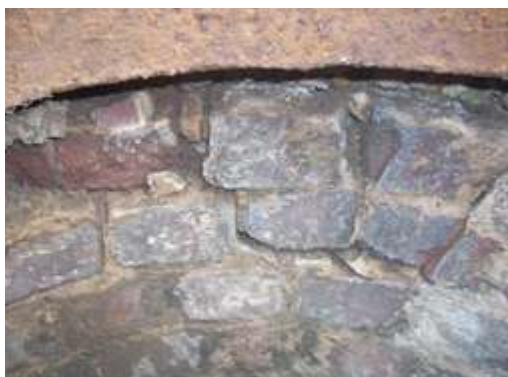
Defect 2

Condition: ☐ Sound ☒ **Cracked** ☐ Root Intrusion ☐ Loose Brick ☒ **Deteriorated**

Condition: ☐ Sound ☒ **Cracked** ☐ Root Intrusion ☐ Loose Brick ☐ Deteriorated

CRACKED AND DETERIORATED
CHIMNEY AND CRACKED CORBEL

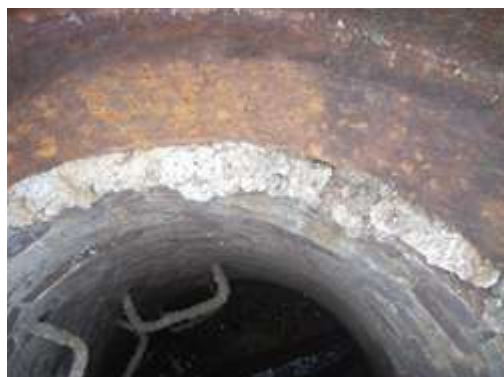
Defect 1

Frame Offset: **1** (in.) Condition: ☒ Sound ☐ Cracked ☐ Leaks

FRAME OFFSET

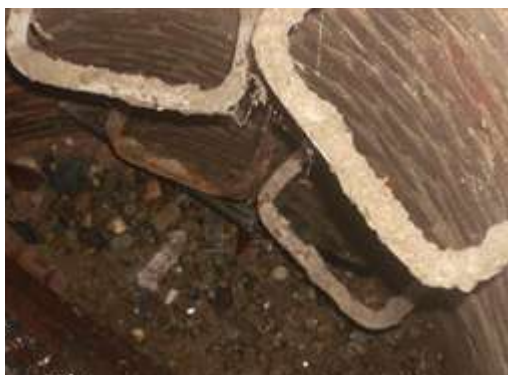
Defect 3

Steps Count: **5** Missing: **0** ☒ **Corroded**

CORRODED STEP

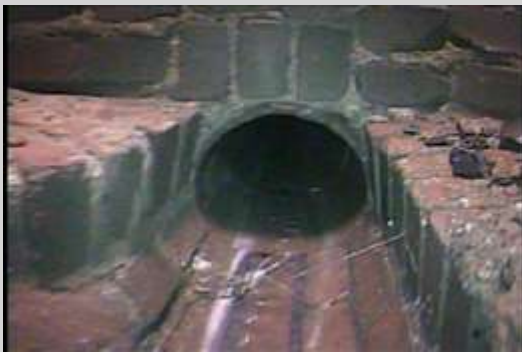
12 O'Clock Outflow

8 in. Circular Gravity Sewer
Pipe Out @ 12 O'Clock

Pipe Height: **8.4** (in.) Rod and Bar (Angled)
Pipe Material: **Clay** ☐ Pipe Lined
Invert Depth: **10.03** (ft.) Flow Characteristics: **Slow**
Deposits: ☒ None ☐ Mud ☐ Sludge ☐ Debris ☐ Grease
Silt Depth: (in.) Deposits Extent:
Infiltration: **None** Pipe Seal Cond: **Sound**

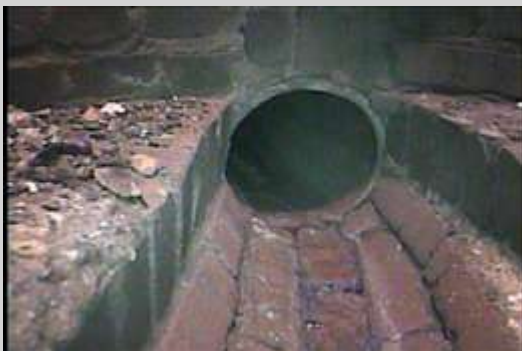
6 O'Clock Inflow

8 in. Circular Gravity Sewer
Pipe In @ 6 O'Clock

Pipe Height: **7.2** (in.) Rod and Bar (Angled)
Pipe Material: **Clay** ☐ Pipe Lined
Invert Depth: **9.82** (ft.) Flow Characteristics: **Slow**
Deposits: ☒ None ☐ Mud ☐ Sludge ☐ Debris ☐ Grease
Silt Depth: (in.) Deposits Extent:
Infiltration: **None** Pipe Seal Cond: **Sound**

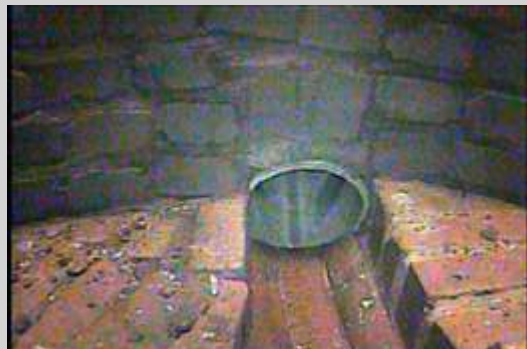
9 O'Clock Inflow

6 in. Circular Gravity Sewer
Pipe In @ 9 O'Clock

Pipe Height: **6** (in.) Rod and Bar (Angled)

Invert Depth: **9.09** (ft.) Flow Characteristics: **None**

Infiltration: **None**

Pipe Seal Cond: **Sound**
